Testing the Flood Resiliency of Historic Exterior Wall Systems, Plaster Using Test Protocol BRS 2-22

Protocol 2 Report

December 2022

BUILDING RESILIENT SOLUTIONS

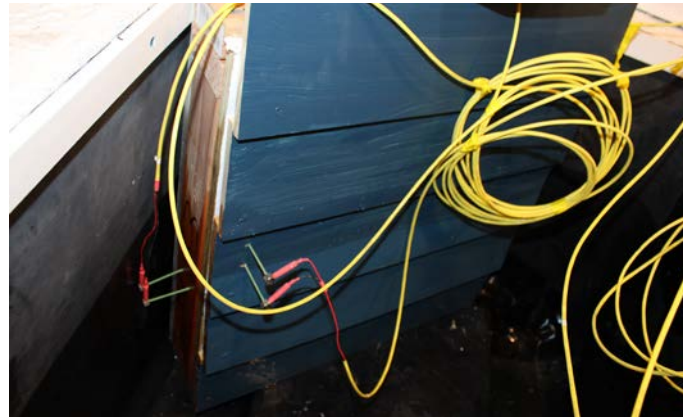
Figure 9 - Sample 1 assembly during draining

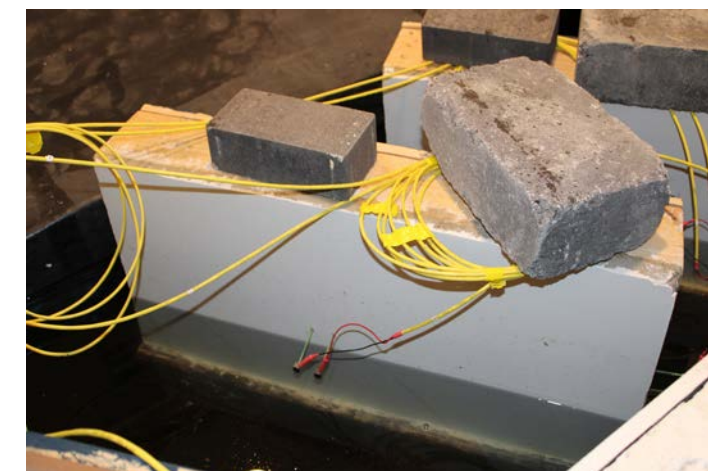
After the wetting period, the siding had expanded from 1.10 inches in width to 1.15 inches; two sections were cupped across the width of the siding, and one section split due to the swelling against the fasteners that held the siding to the framing. The plaster and lath both appeared to be in good condition and no surface deformations were visible. The plaster did develop a sandy, crystal-like substance above the waterline. The wood lath was intact; fasteners were holding well against the plaster and no cracking was visible between the framing and the plaster. The framing members, while laden with moisture, did not change in size in any measurable form. This may be a result of the larger sections of wood and heavy sill used in the framing, which tend to show less overall movement in cross-sectional dimensions than smaller sections of wood.

Figure 13 - Sample 1 assembly during flooding.

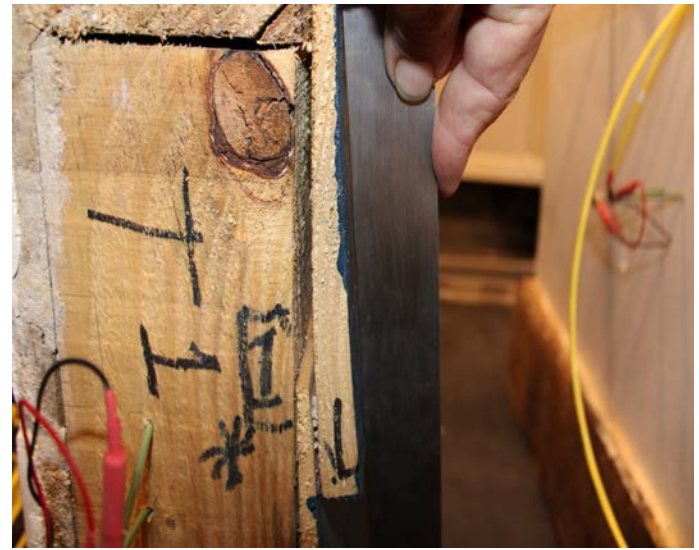
change in cross sectional dimensions. The siding remained cupped. The split that had previously developed in one piece of siding separated to a dimension of 0.25" at the leading edge; this split was located in the center of the broad face and appeared to be a result of cupping and swelling that placed stress on the board since it was nailed in place and unable to move or grow across the grain. The sample was photographed to record its appearance (See Figure 14).

Figures 14 - Sample 1 showing cupped siding against a flat edge.

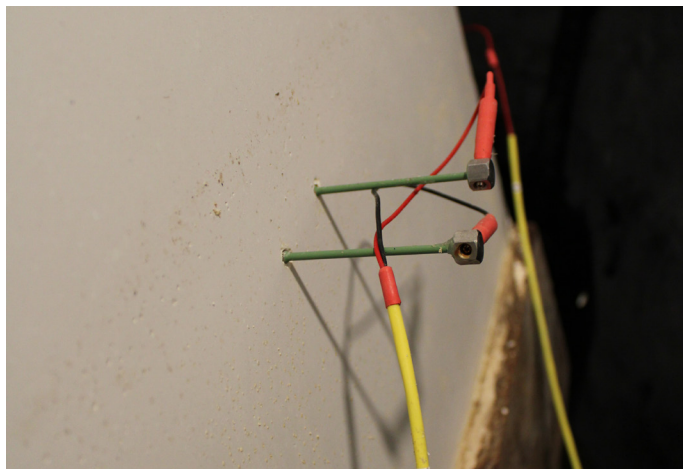
Figure 17 - Detail of Sample 2 assembly showing crystal granules formed on drywall after flooding

changes in measured values or deformations. The efflorescence (crystals) that formed on the plaster were easily removed with a soft brush and the surface was unchanged. No noticeable changes in the fasteners or the connections to the lath or substrate were observed in any of the samples. The drywall was the most surprising performer. The surface, while a little rough, had little to no change in the measured thickness of the wall framing and siding. The edges where water could easily penetrate the joint between the paper and gypsum performed poorly. This would be an issue in a wall assembly with many cut openings for electrical outlets, doors, windows, etc. The performance of the drywall, and perhaps the plaster, may have been influenced by the application of oil-based primer and high-quality latex paint that was in good condition. This may not be the case with many wall assemblies in the field as paint may have been abraded in areas on the wall which would allow more moisture to penetrate the paper/gypsum connection.

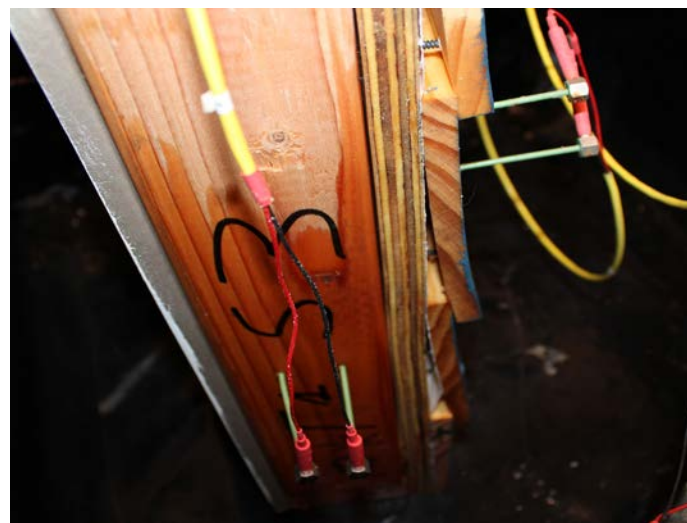
and the bottom averaging 32%. The drywall contained a uniform moisture content of 32%. The siding averaged 22.4%, with the top averaging 12% and the bottom averaging 32%. The overall wall thickness swelled from 5.85" to an average of 5.99" and the siding expanded from 1.02" to an average of 1.07". The drywall was rough to the touch, easily scratched, and the paper had separated from the gypsum on the edges. Physical changes in the siding were the most visible change in the sample. The siding showed significant cupping and some cracking around the nails.

Figure 19 - Sample 3 assembly post-draining showing wet areas on sample and warped siding
