TESTING THE WATERS:

CHALLENGES ACHIEVING RESILIENCY

BUILDING RESILIENT SOLUTIONS
Thoughtful, informed retrofit design.

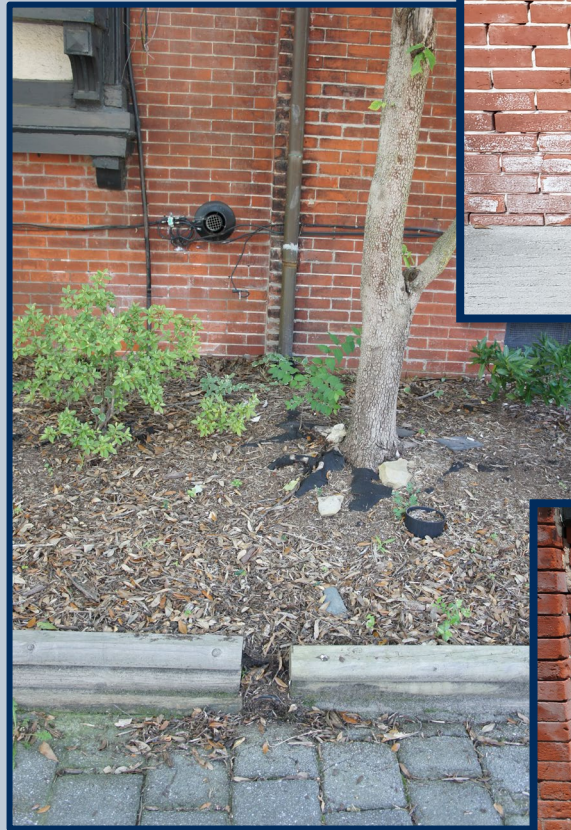
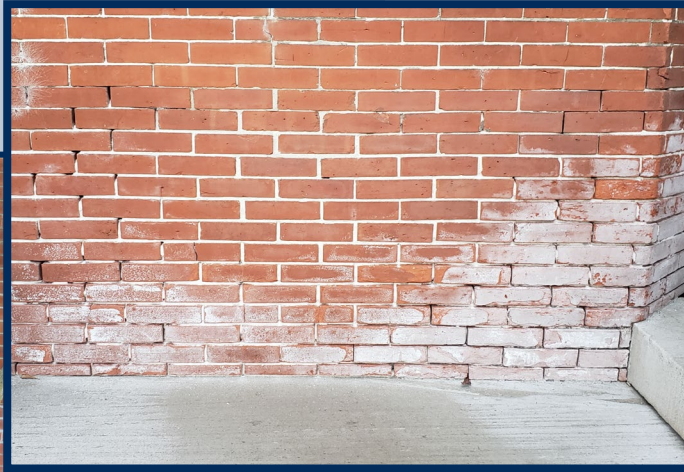
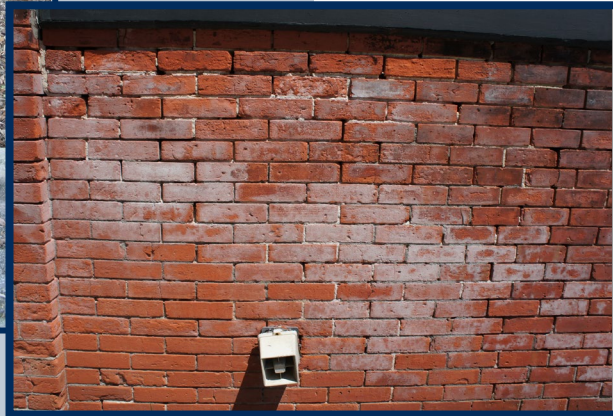
CASE STUDY 1: GHENT RESIDENCE

Findings:

- Soil and brick moisture content impacted by tidal position, temperature, and relative humidity
- Rain events compound water accumulation
- Most significant impact is the forced movement of moisture up the masonry column

Conclusion: The focus of the retrofits should be based on eliminating introduction of ground water and improving the evaporation of moisture from the surrounding soils

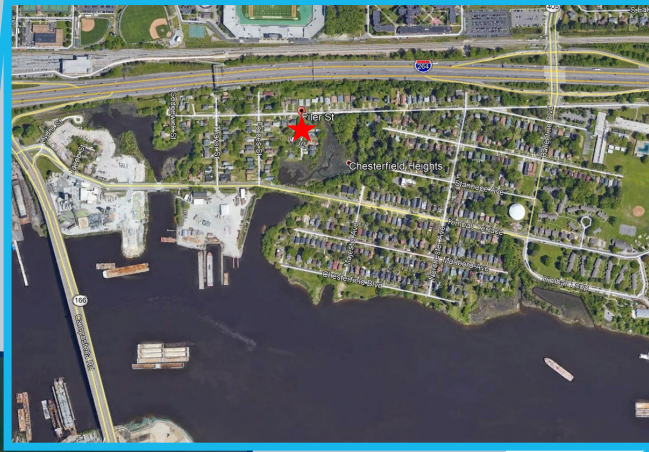
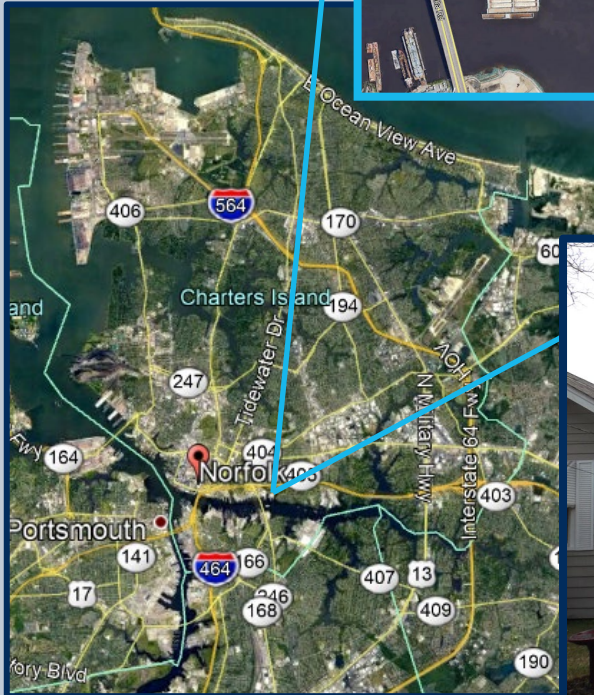
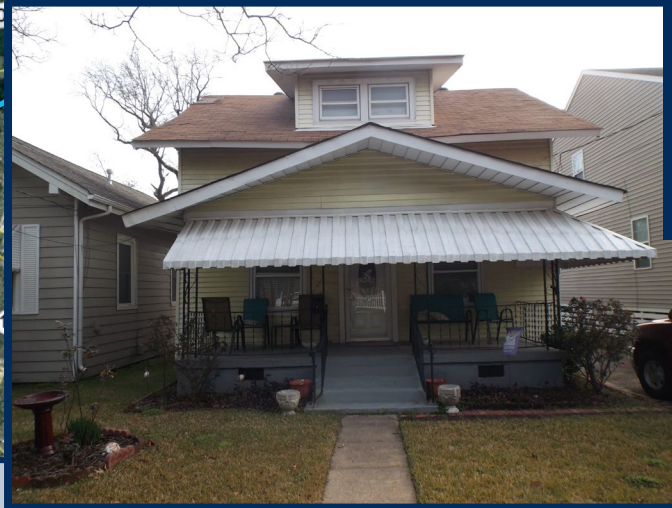
CASE STUDY 2: CHESTERFIELD HEIGHTS RESIDENCE

- Directly north of the Elizabeth River
- House Built: c1921
- Historic District Designation(s):
 - Chesterfield Heights Historic District (Virginia Landmarks Register)
 - Chesterfield Heights Historic District (National Register of Historic Places)
 - Potentially eligible for exemption
- Reason for initial contact between client and CPG/MR/BRS:
 - Disruption and damage from multiple significant flood events in a short period

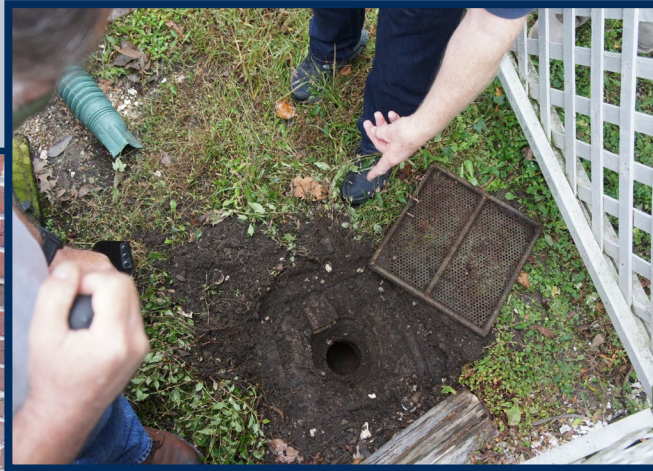
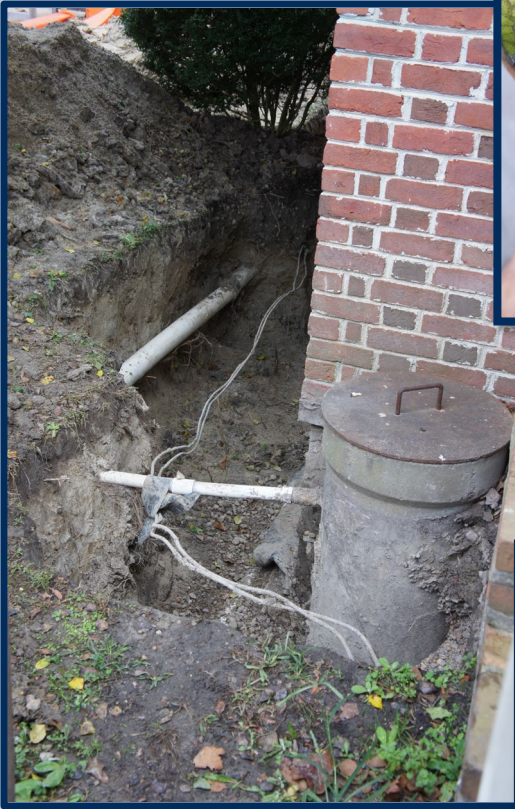
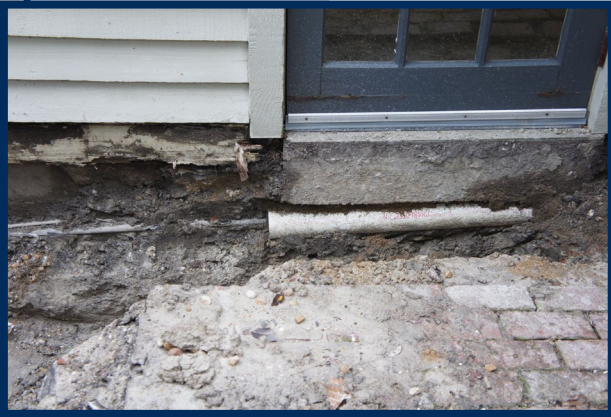
CASE STUDY 4: MUNICIPAL HOUSE MUSEUM

Findings – multiple conditions contributing to moisture problem:

- Poor drainage
- Poor grading
- Organic material near foundation walls
- Earlier waterproofing efforts failed
- Addition of the concrete slab forced more moisture up the masonry column, adding to the problem
- Unregulated RH in basement

Conclusion: Reinstalling similar waterproofing modern materials will not abate the issues. Also, current grading has brought water to building rather than away from it.
