Testing the Flood Resiliency of Historic Exterior Wall Systems, Plaster, Using Test Protocol BRS 2-22 was undertaken to study the survivability of historic plaster wall assemblies and exterior cladding materials that have been exposed to limited duration water inundation, as is commonly experienced during tidal flooding events. The tests were performed in accordance with "BRS 2-22: Test Protocol for Flood Testing of Exterior Wall Systems," developed by Georg Reichard, Ph.D., P.E. for BRS to create a consistent assessment method regarding the durability and re-workability of wall assemblies after flooding events.

BRS's second test, Protocol 2: Testing the Flood Resiliency of Historic Exterior Wall Systems, Plaster, Using Test Protocol BRS2-22, was made possible and funded through a partnership with RISE: Resilience Innovations.

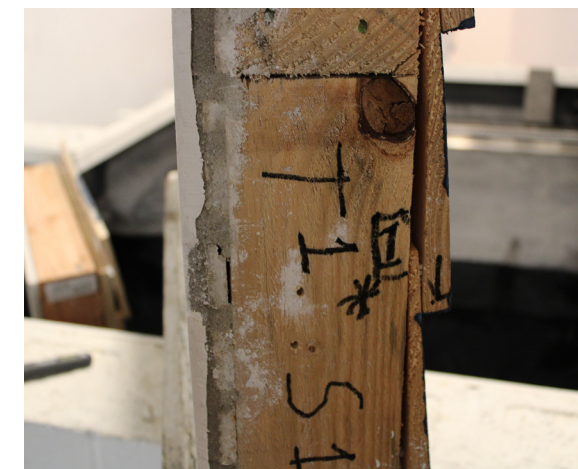
Detail of wood lath and plaster wall assembly

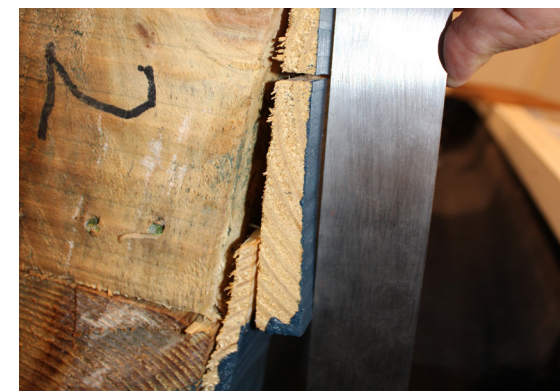
Wall Assembly 2 (Wire Lath & Plaster) showing split siding post-drying

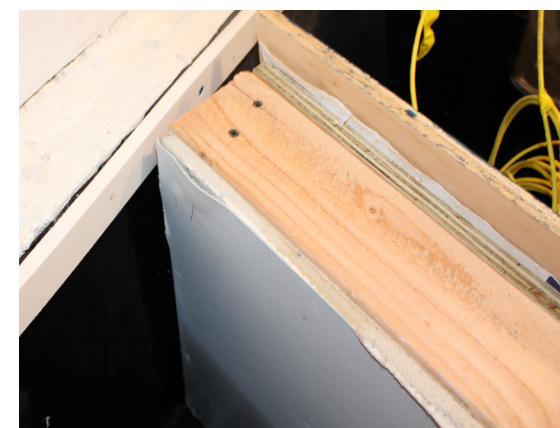
Wall Assembly 3 (drywall) peeling at edges post flooding

- Drywall edges where water could easily penetrate the joint between the paper and gypsum performed poorly.
- Plaster on wood lath performed the best, expanding the least in cross section and returning closest to pre-testing values. Performance was based on a sample's ability to return to its pre-testing size, form, and appearance.
