EXECUTIVE SUMMARY - TEST 1.1

Testing the Flood Resiliency of Historic Wood Flooring Material Using Test Protocol BRS 1-22

DECEMBER 2022

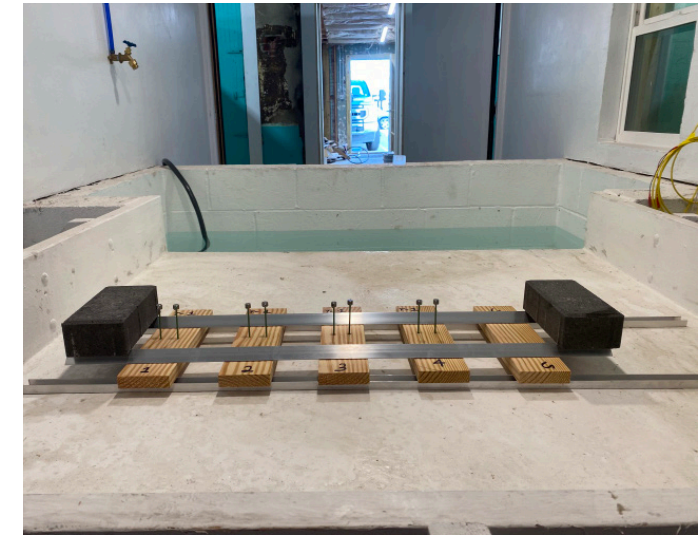
Test 1 prior to test flooding

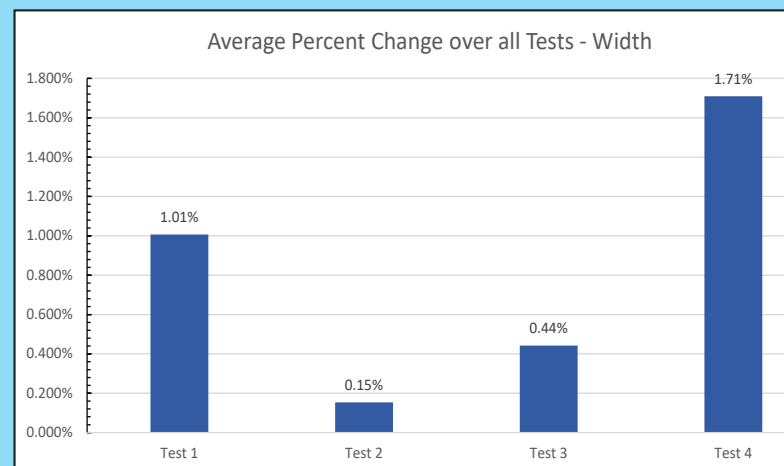
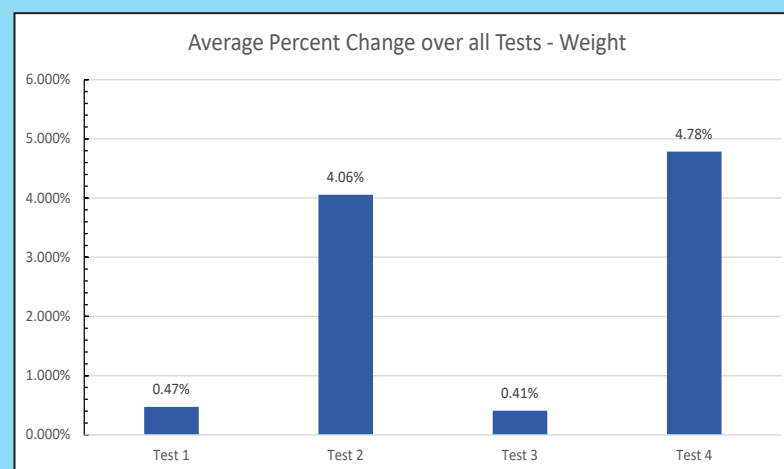
The graphs to the right illustrate the average percent change between pre-wetting and post-drying width, thickness, and weight measurements for each of the four tests performed in this test. The percentages shown are the averages of the percent change measurements for each sample within a test. Tests included the following sample specimens:

- Test 1: Modern Southern Yellow Pine (5 pieces)
- Test 2: Old Growth Southern Yellow Pine, Rift Sawn (5 pieces)
- Test 3: Old Growth Southern Yellow Pine, Flat Sawn (4 pieces)
- Test 4: Modern White Oak & Modern Southern Yellow Pine (3 pieces & 4 pieces respectively)

These changes were measured with digital calipers and a bench scale to ensure accuracy and consistency in measurement output.

- Modern growth Pine samples exhibited little dimensional stability, which when nailed in place would cause the floor to buckle and fasteners to fail, even on rift sawn samples.
- Modern White Oak samples exhibited similar changes that would cause much of the same damage as modern Pine.
- Dense growth Pine samples exhibited the smallest expansion in width.
- Overall, the dense growth Pine outperformed the low-density Pine during both wet and dry conditions for all categories except thickness.
- There is a direct correlation between weight gain and water absorption; this gain manifests in significantly increased width and nominally increased thickness.

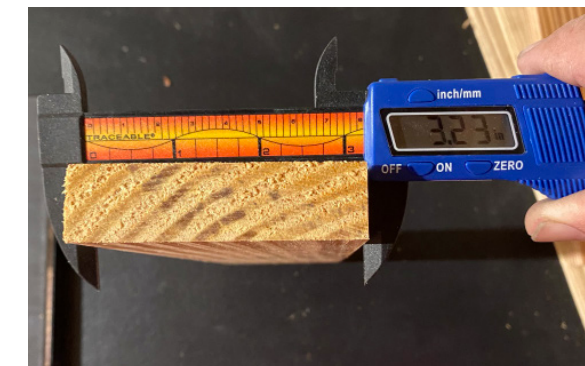
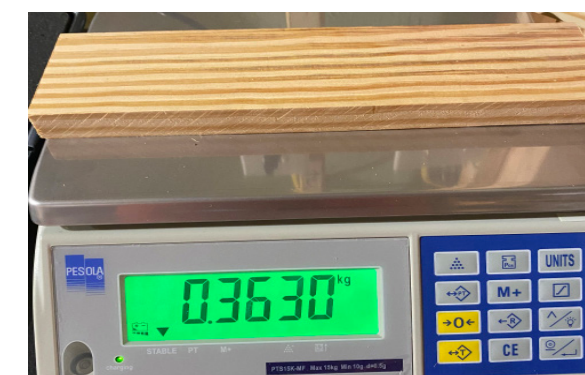
Precise measurements taken before and after testing
