Testing the Flood Resiliency of Historic Wood Flooring Material Using Test Protocol BRS 1-22

Protocol 1 Report

October 2022

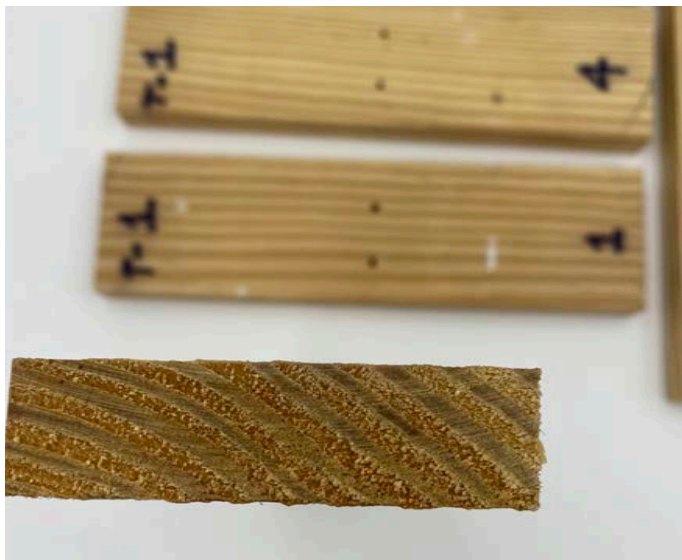
Figure 1 - Test 1 Wood material samples.

Materials were selected based on the type of historic materials used in pre-1940 construction in Tidewater Virginia and the modern materials that have replaced them in later construction. Samples were selected based on species, grain orientation, and growth density. Samples were cut to a uniform size for individual tests to provide consistent data samples. Samples were of Southern Yellow Pine, *Pinus sp.*, and White Oak, *Quercus sp.* Sections of old, dense growth Southern Yellow Pine, modern growth Southern Yellow Pine, and dense growth White Oak were used for testing. Samples were selected for consistency in density and mechanical characteristics of thickness, length, width, and flatness. The selected samples were 12" long, 3/4" thick, and 3 1/4" wide, nominal. The precise dimensions of each sample were recorded prior to and upon completion of each test.

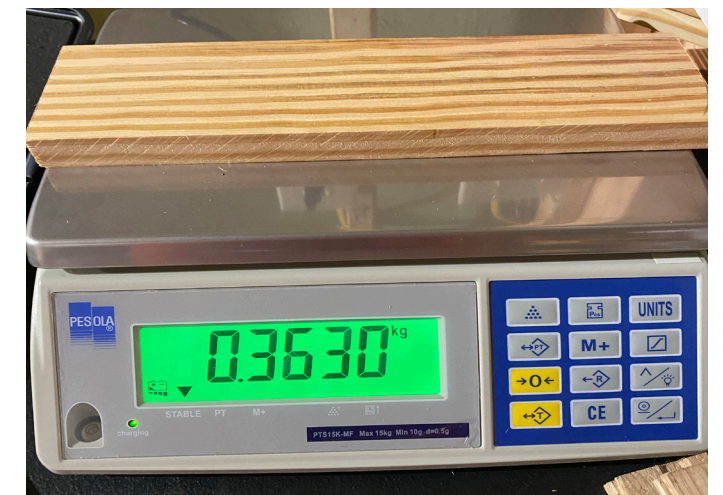
Figure 4 - Test material being weighed.

- Thickness and width were measured in four locations, using digital calipers to the nearest .001 inch.
- Moisture content was measured using a pin-less Wagner moisture meter to the nearest .01 percent.
- Post-test moisture was measured using the oven dry method; Moisture Content = (Initial Weight - Dry Weight) / Oven Weight.

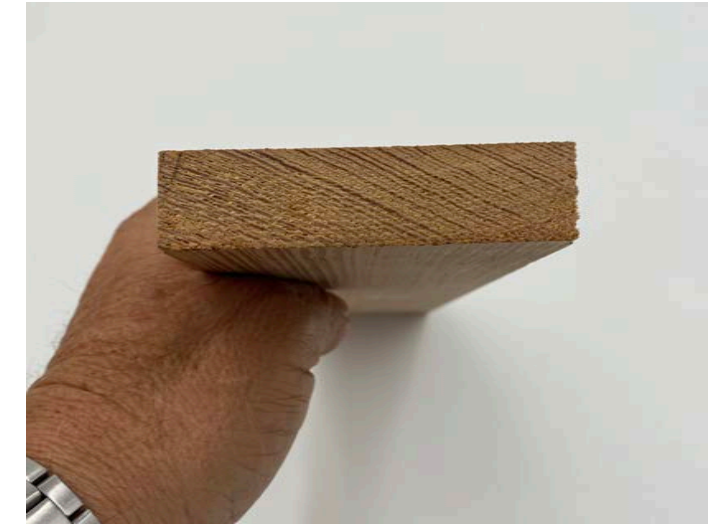
Figure 9 - Test 2 materials showing typical density.

Test specimens for Test 2 were composed of rift sawn, old growth Southern Yellow Pine, *Pinus sp.*, often referred to as heart pine. The samples were dense growth, and laden with resin. The samples were examined and pre-testing data points were recorded. The samples were approximately 3.25-inches in width, 0.75-inches in thickness, and 12-inches long. The samples weighed an average of 0.42 kg. Moisture content within the samples averaged 15%. No geometric deformations were observed.

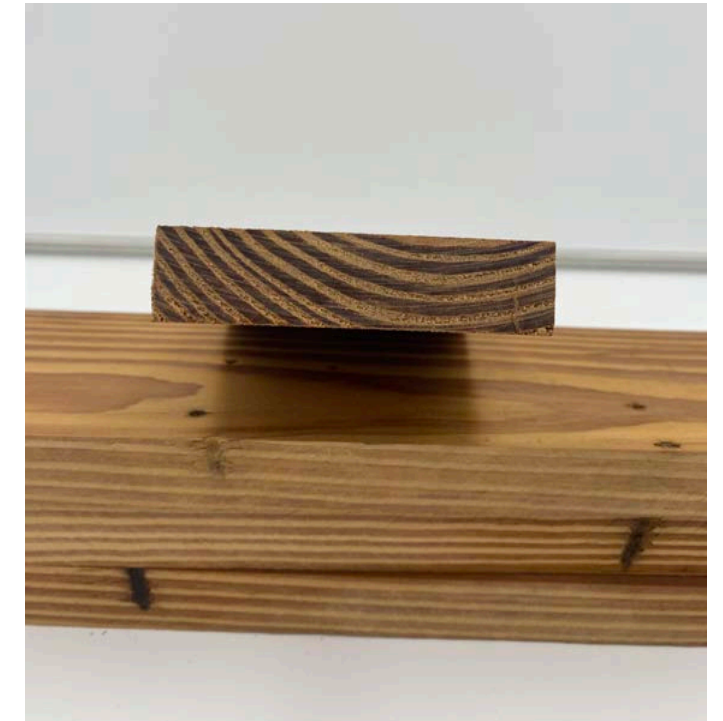
Figure 11 - Test 3 materials showing typical density.

Test 3 samples were composed of recycled old growth Southern Yellow Pine, *Pinus sp.* The specimens were flat sawn and slightly wider growth than those of Test 2; however, the Test 3 samples were more resinous in nature. Pre-testing data points for each sample were collected as listed in the design protocol and recorded. Each sample was photographed, and a visual inspection of any geometric deformations were recorded. The samples were approximately 3.25-inches in width, 0.75-inches in thickness, 12-inches long, and weighed 0.40kg. The moisture content prior to flooding was 15%. The samples were flat, square, and showed no noticeable geometric deformations.

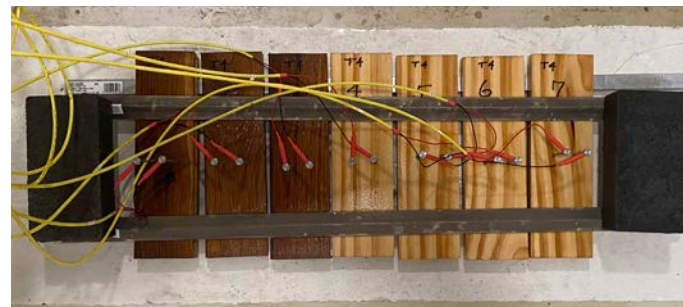
Figure 14 - Test 4 materials during post-drying.

Post-drying data points revealed the White Oak samples had average gains of 1% in width, 1.8% in thickness and 8% in weight. Geometric deformations of crowning on White Oak samples 1 and 2 that were recorded prior to testing were still noticeably visible, and there was now cupping on sample 2. Post-drying moisture content averaged 14.6% measured by a pin-less meter; however, when calculated by oven dry method the moisture content was assessed as 9.7%.

Data points collected post-drying revealed that the Southern Yellow Pine samples had an average gain of 2.3% in width, 2.3% in thickness, and 2.0% in weight. Moisture content measured by pin-less meter averaged 12.25%, and moisture content calculated by oven dry method revealed a moisture content of 12.8%. No noticeable geometric deformations were recorded.

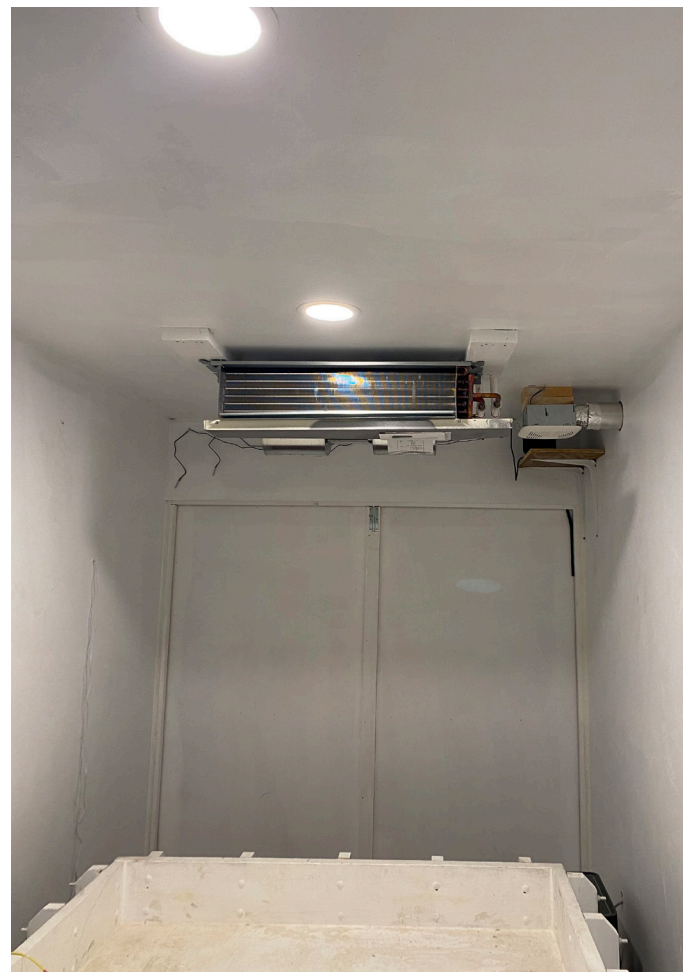
Figure 17 - Test chamber

Conditions within the test chamber during the drying period were held at a constant temperature of 70 degrees Fahrenheit and 70% RH with little significant change. The constant environment and modest conditions allowed for reasonably slow drying. Variations in drying conditions would perhaps bring about additional changes to the samples.

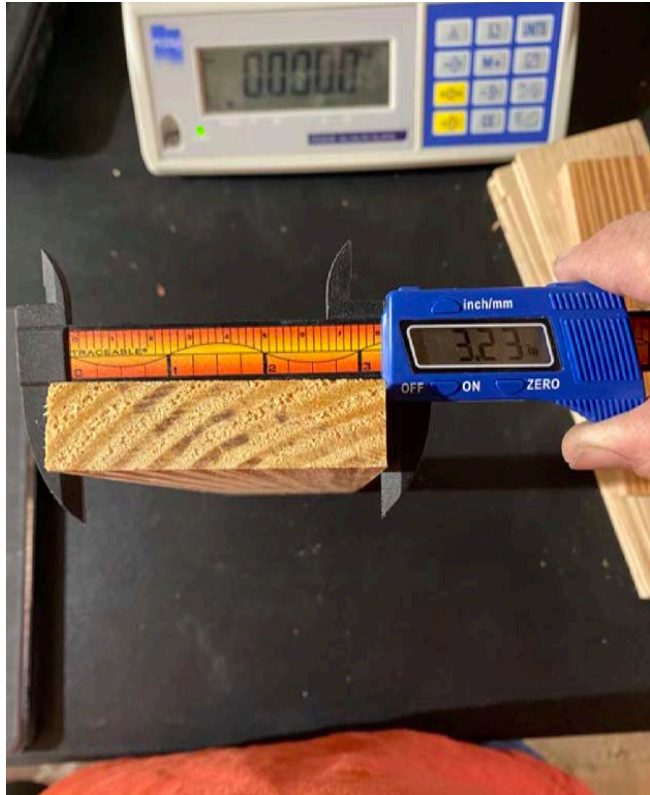
Appendix A4 Figure 1 - Example of collecting specimen width

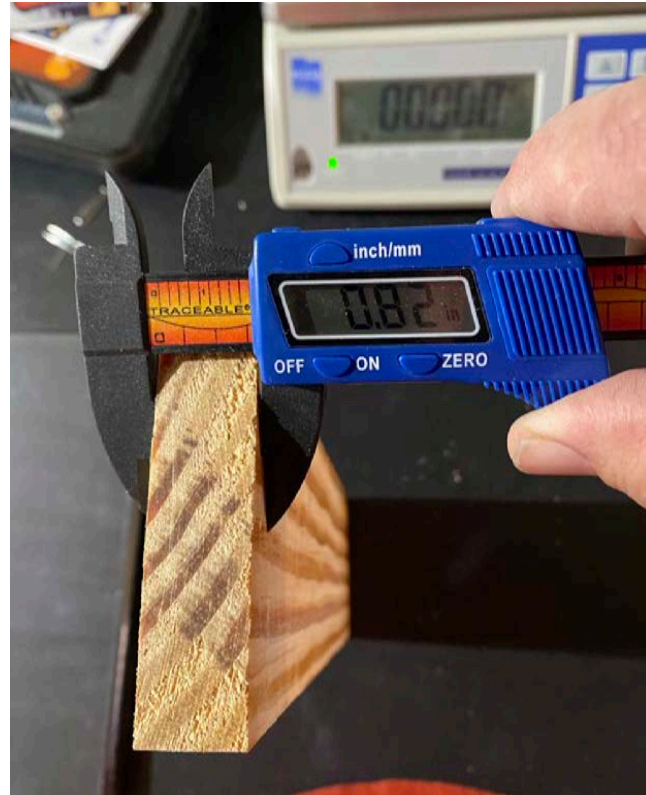
Appendix A4 Figure 2 - Example of collecting specimen thickness

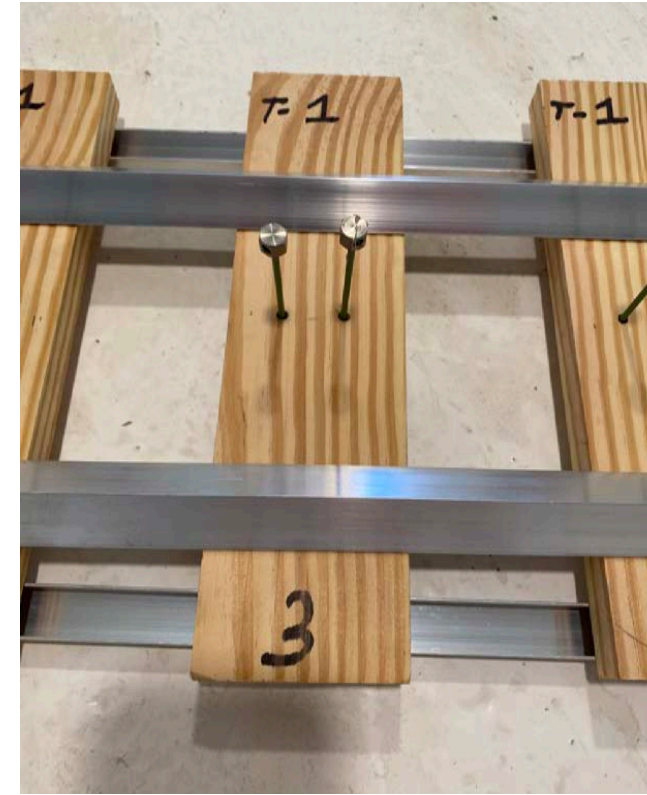
Appendix A4 Figure 5 - Typical probe locations on specimens

To monitor the moisture content of each sample, two 0.187-inch holes were drilled approximately along the centerline lengthwise of each sample. The holes were 1 1/2-inches apart and 3/8' deep, so that the probes from the Lignomat system could be inserted into the sample.

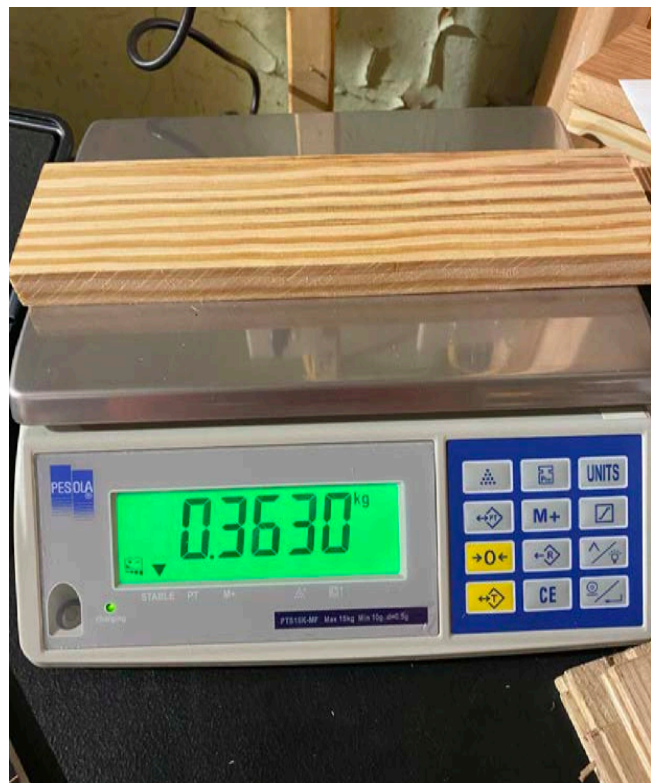
Appendix A4 Figure 3 - Example of collecting specimen weight measurements

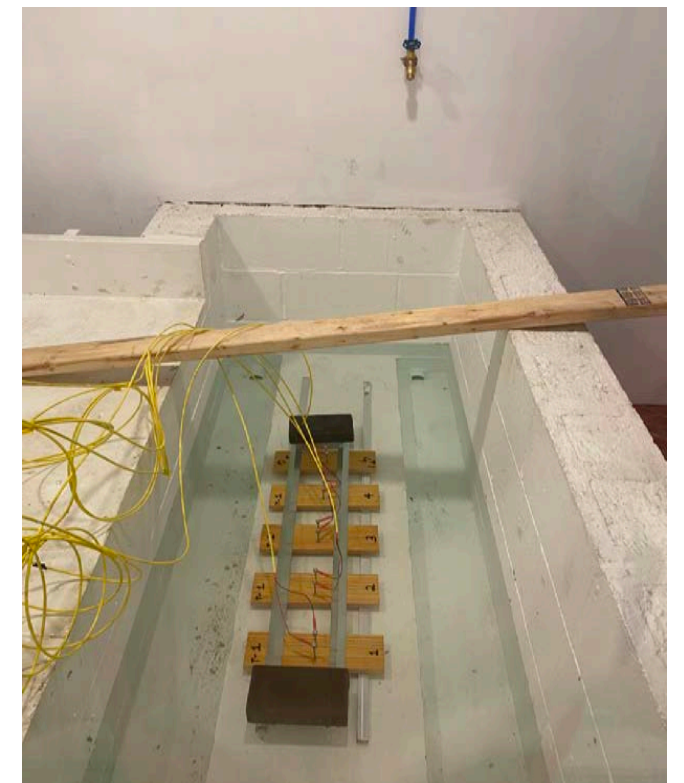
Appendix A4 Figure 8 - Test 1 specimens during flooding

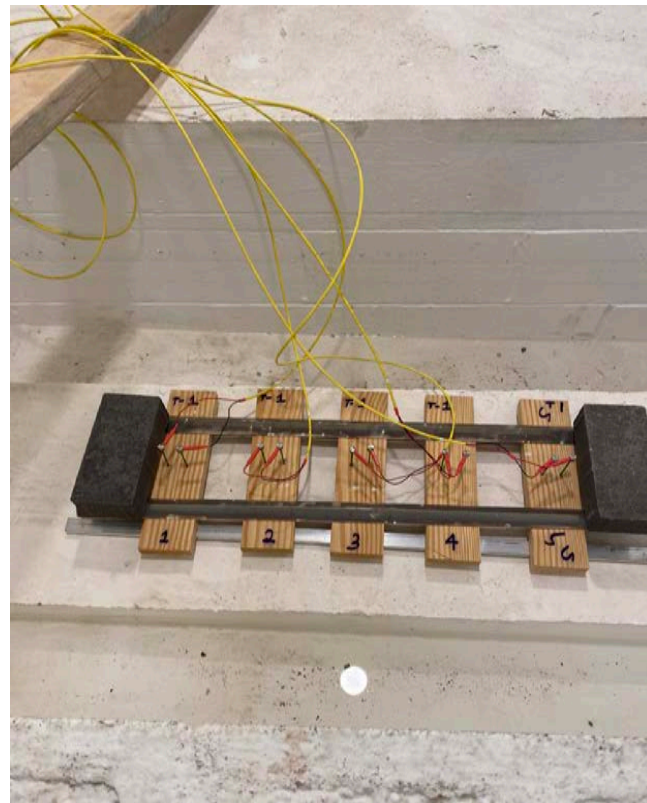
Appendix A4 Figure 10 - Test 1 specimens after draining and beginning to dry

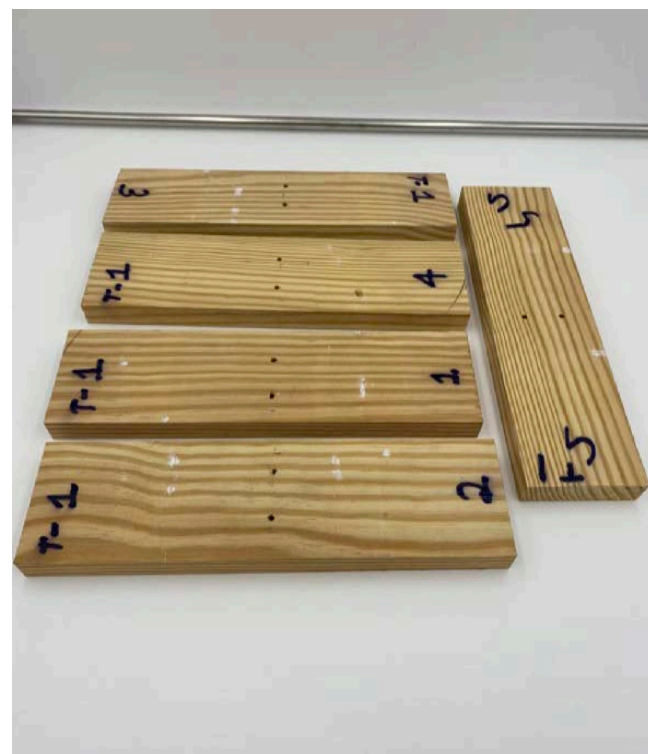
Appendix A4 Figure 11 - Test 1 specimens after drying

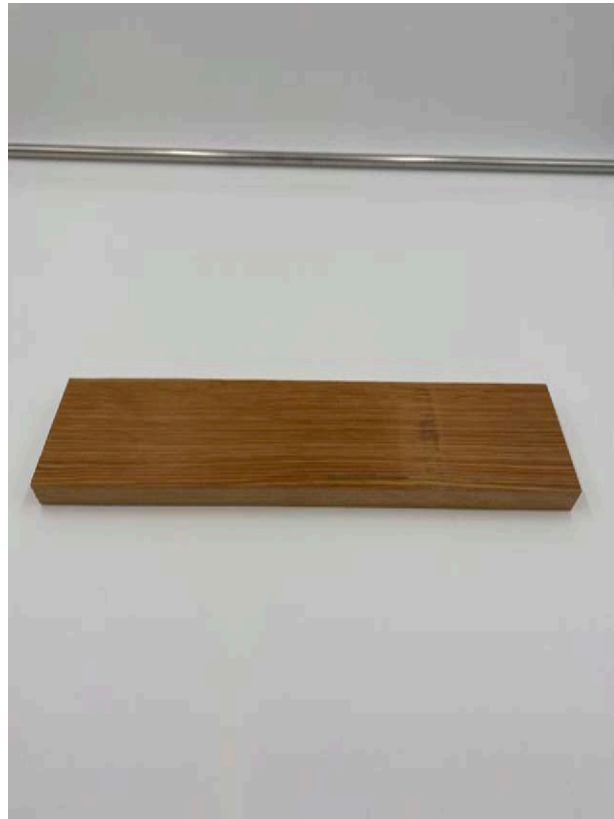
Appendix B4 Figure 1 - Typical Test 2 specimen

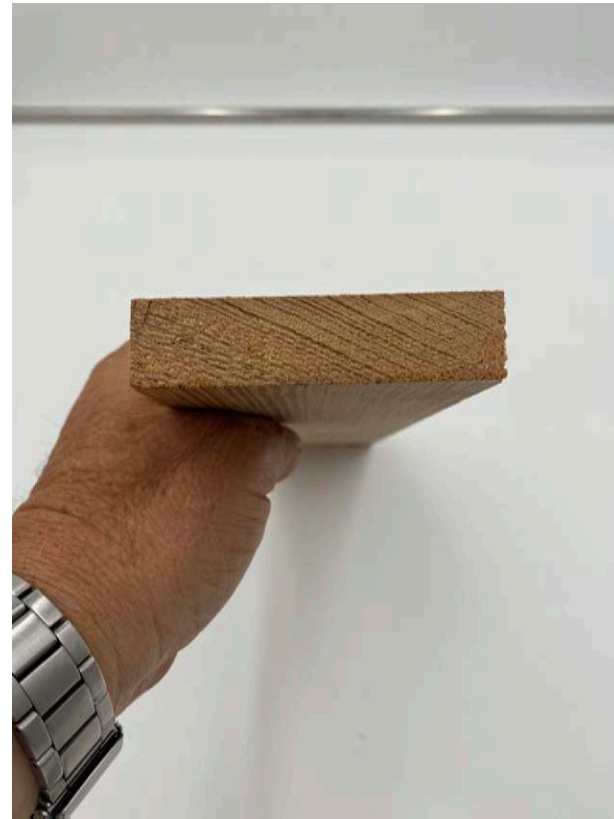
Appendix B4 Figure 2 - Typical Test 2 specimen

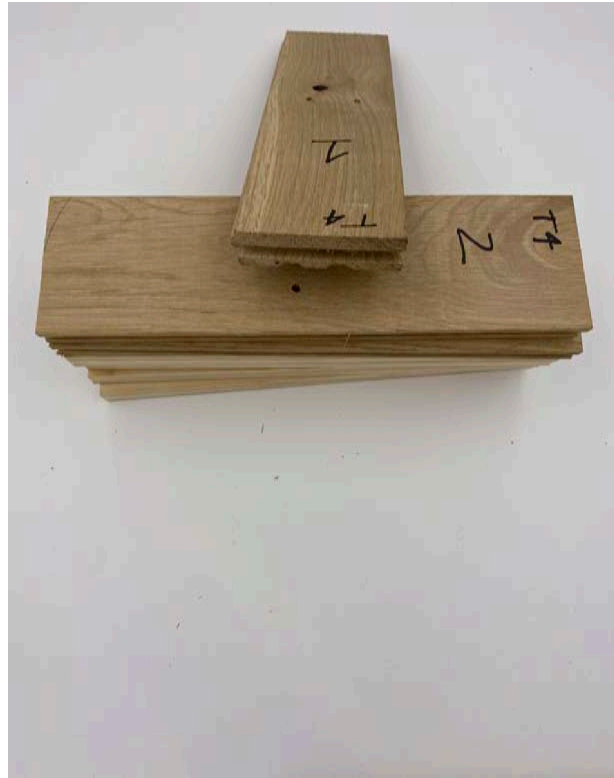
Appendix D4 Figure 1 - Test 4, specimens 1 and 2 before testing

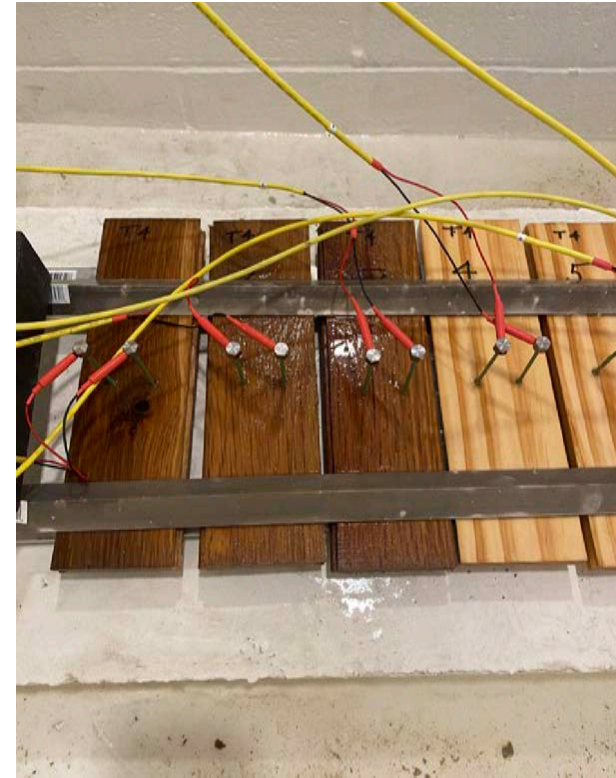
Appendix D4 Figure 5 - Test 4, specimens 1-5 after draining
