Testing the Flood Resiliency of Historic Exterior Wall Systems, Plaster Using Test Protocol BRS 2-22

Protocol 2 Report

December 2022

BUILDING RESILIENT SOLUTIONS

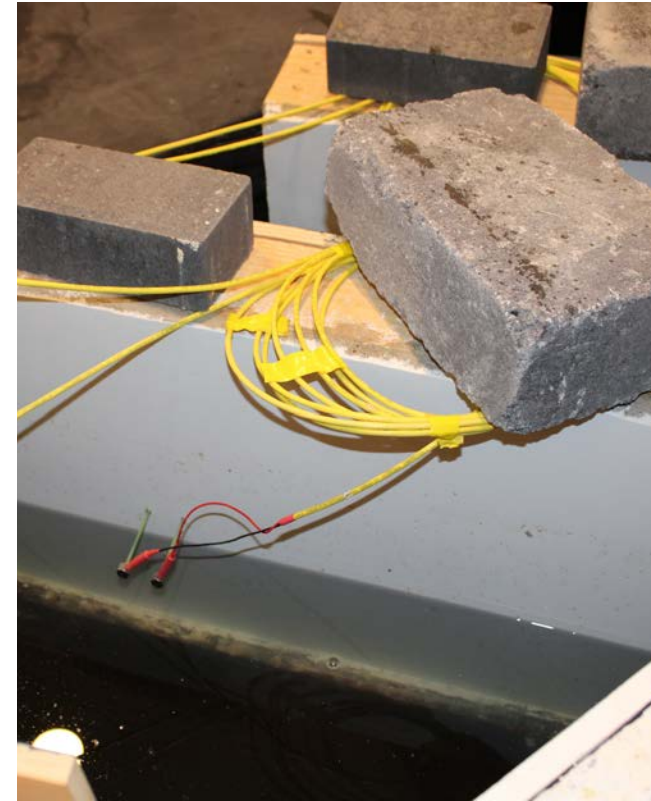
Appendix A3 Figure 13 - Sample 1 showing water level during flooding period.

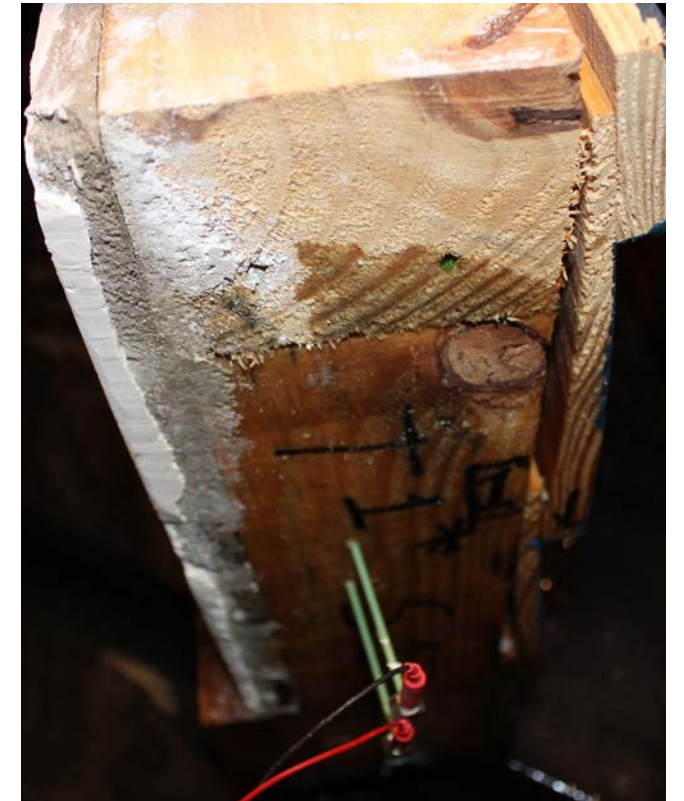
Appendix A3 Figure 14 - Sample 1 showing height of water absorption post-draining.

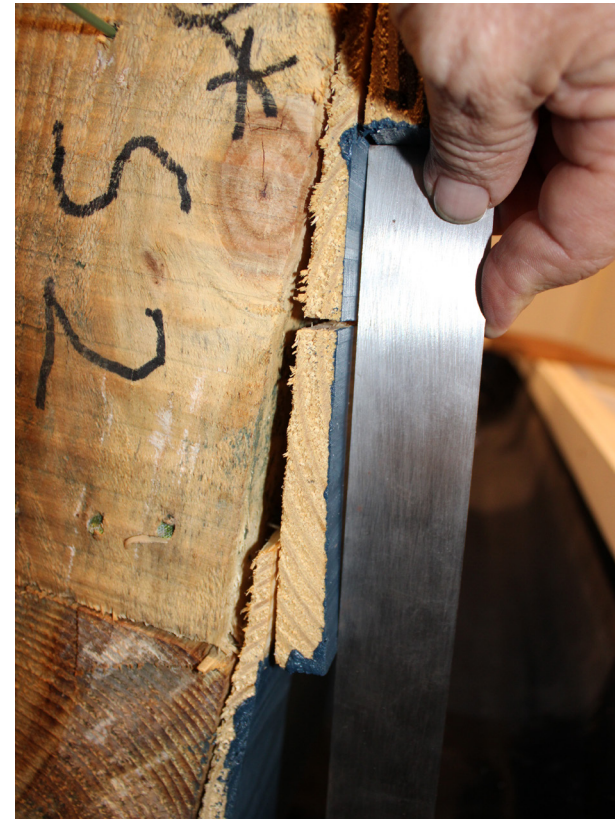
Appendix B3 Figure 13 - Sample 2 showing warping of siding after drying period against a straight edge.

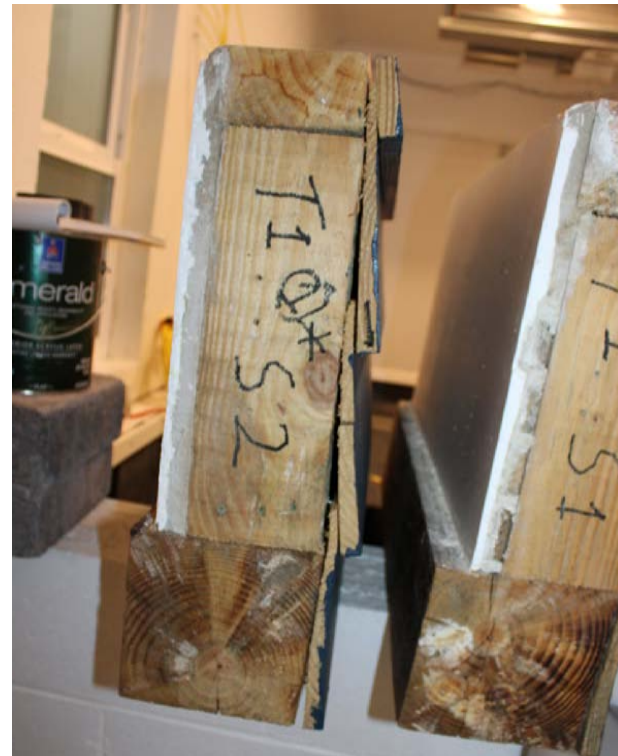
Appendix B4 Figure 12 - Sample 2 section view after the extended drying period.

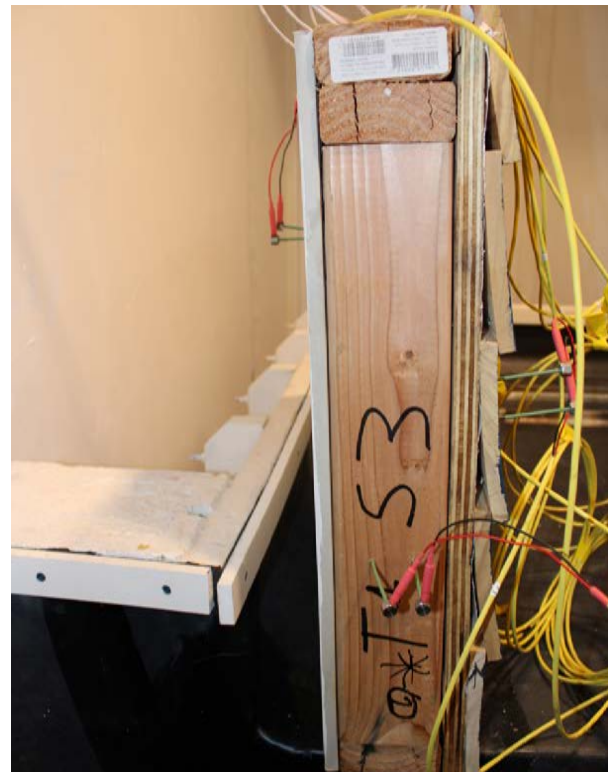
Appendix C3 Figure 12 - Sample 3 during extended drying period with Lignomat probes installed.
