TESTING THE WATERS:

CHALLENGES ACHIEVING RESILIENCY

BUILDING RESILIENT SOLUTIONS
Thoughtful, informed retrofit design.

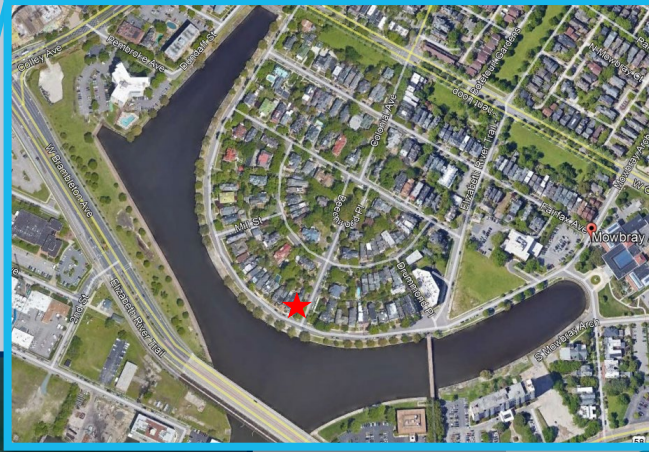
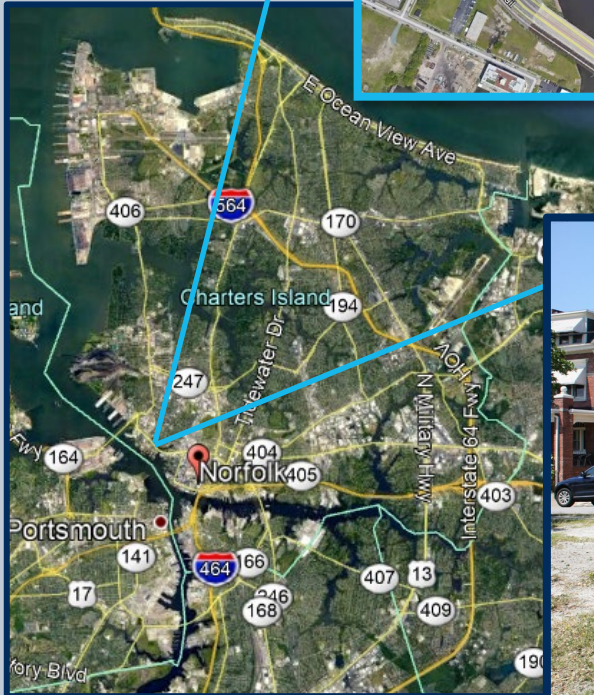
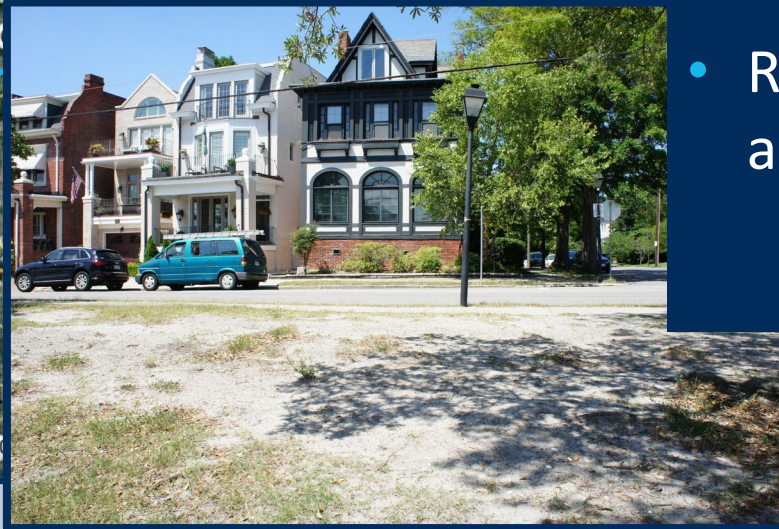
- Directly across from The Hauge waterway
- House Built: c1901
- Historic District Designation(s):
 - Ghent Historic District (Local District)
 - Ghent Historic District (Virginia Landmarks Register)
 - Ghent Historic District (National Register of Historic Places)
 - Potentially eligible for exemption
- Reason for initial contact between client and CPG/MR/BRS:
 - Powdering of the brick on both interior and exterior elevations

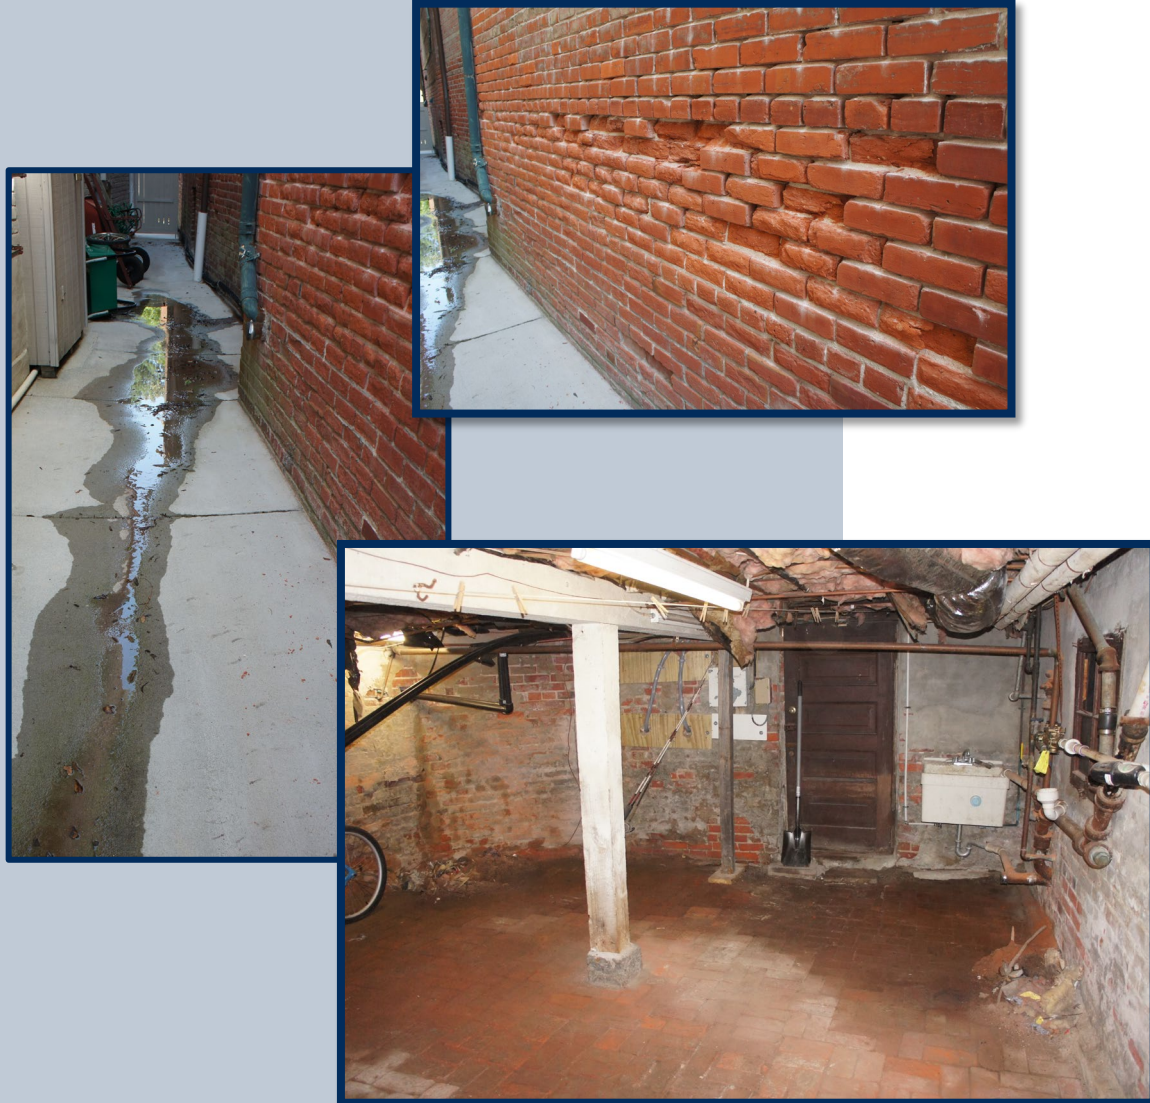
- Flood Zone: AE (High Risk)
- Base Flood Elevation: 8 feet
- Design Flood Elevation: 11 feet
- First Story Floor Level: 4 feet
- No known FEMA NFIP claims
- Initial Assessment:
 - Limited pervious area
 - Exterior brick and mortar deterioration
 - Interior basement deterioration

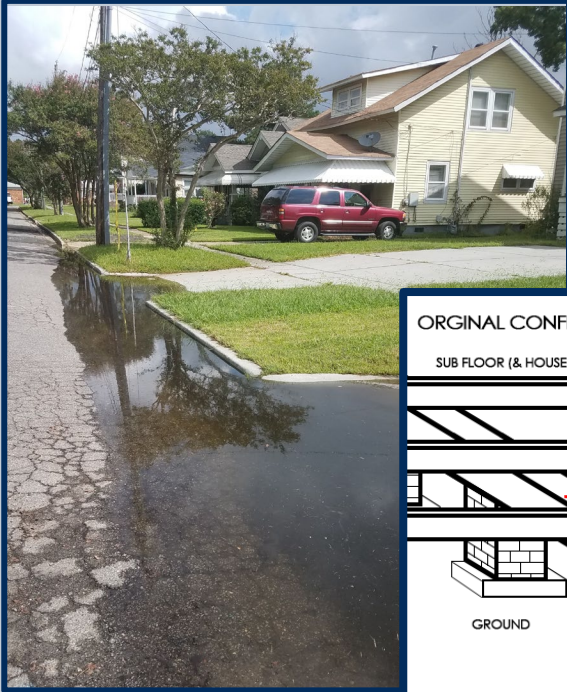
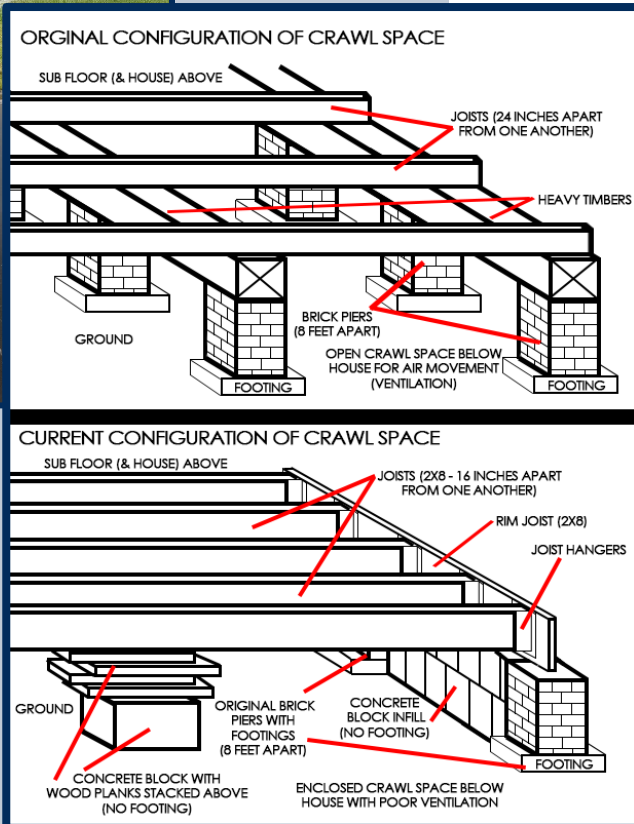
- Flood Zone: AE (High Risk)
- Base Flood Elevation: 9 feet
- Design Flood Elevation: 12 feet
- First Story Floor Level: 4 feet
- Second Story Floor Level: 13 feet
 - 1 foot above DFE
- Two FEMA NFIP claims since 2009
 - Repetitive Loss Property
- Initial Assessment:
 - Neighboring new construction impacting client's home
 - Previous NFIP funded repairs did not address underlying factors
 - Replacement material issues from previous work

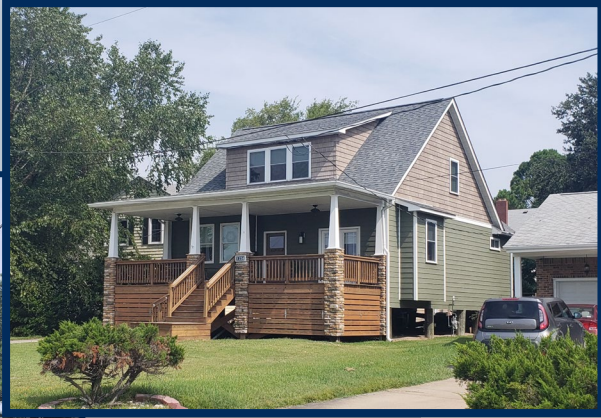
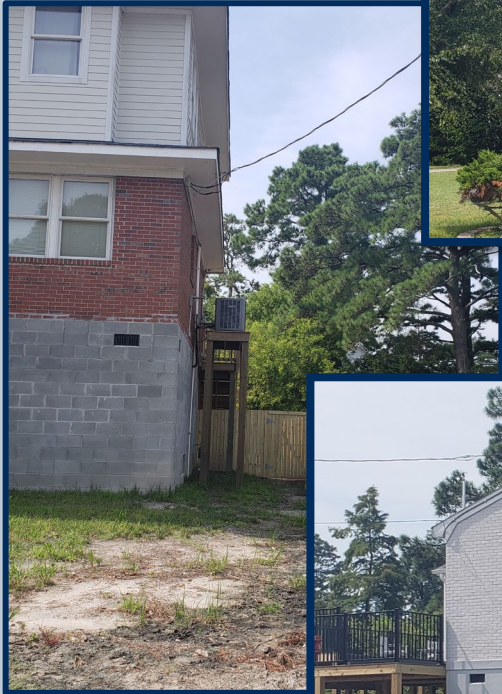
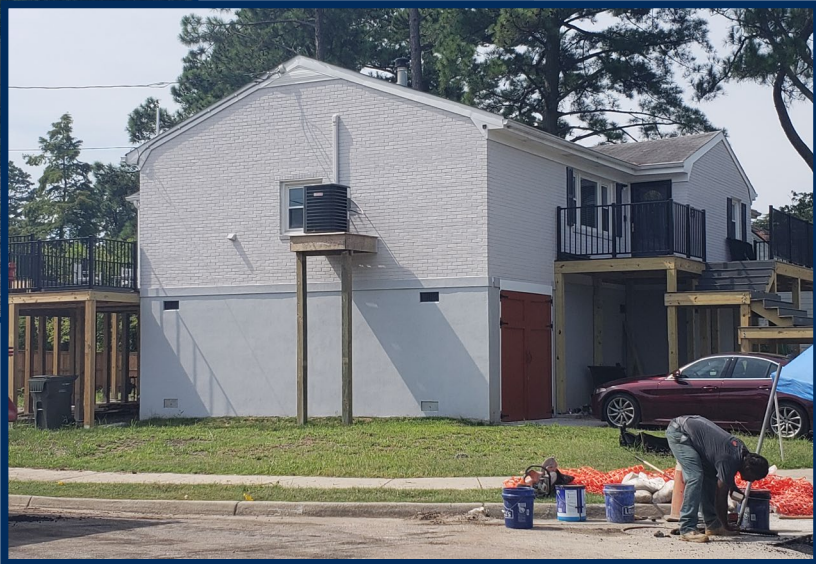
- Flood Zone: AE (High Risk)
- Base Flood Elevation: 9 feet
- Design Flood Elevation: 12 feet
- First Story Floor Level: 3 feet
- Second Story Floor Level: 12 feet
 - Approximately at DFE
- Property Concerns:
 - Has been for sale off and on every year since 2017
 - Sunny day flooding more than once a month, limiting access to property
 - Majority of adjacent properties are primary residences that have been raised using FEMA funding

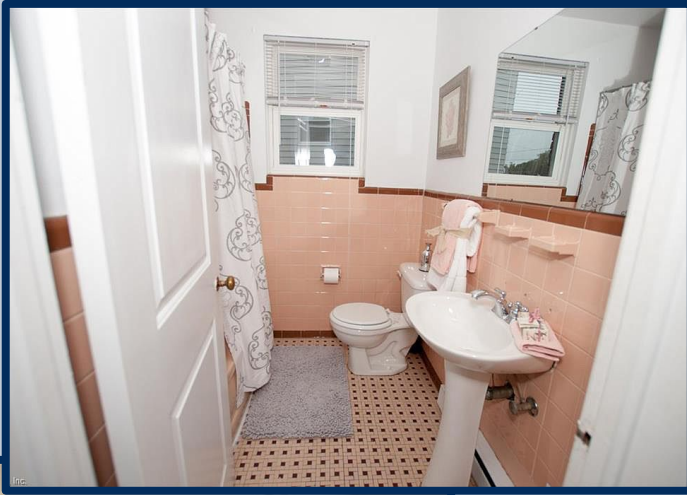
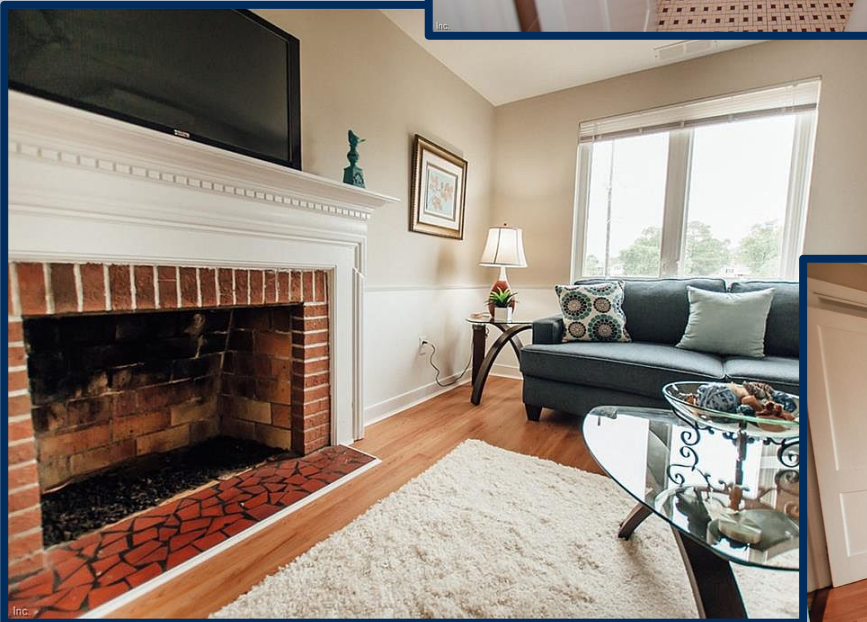
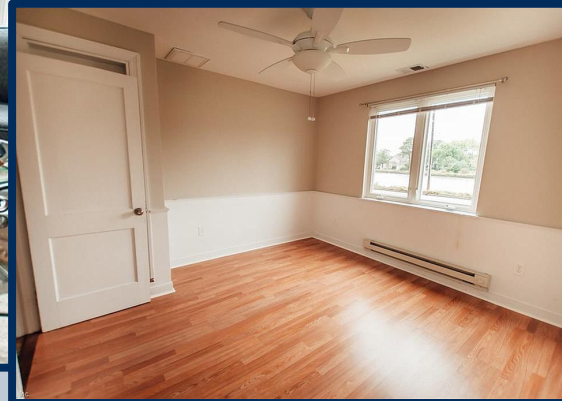
- First flood remediation funded with NFIP claim
- NFIP claim resulted in removal of historic floor framing, flooring, and plaster
 - Property owner deemed this a mistake
- Property owner maintains flood insurance, but self-funded remediation of second flood to implement new approach which did not meet NFIP requirements

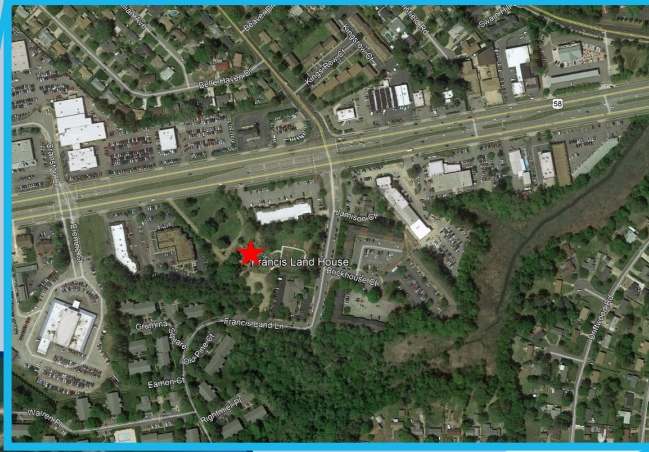
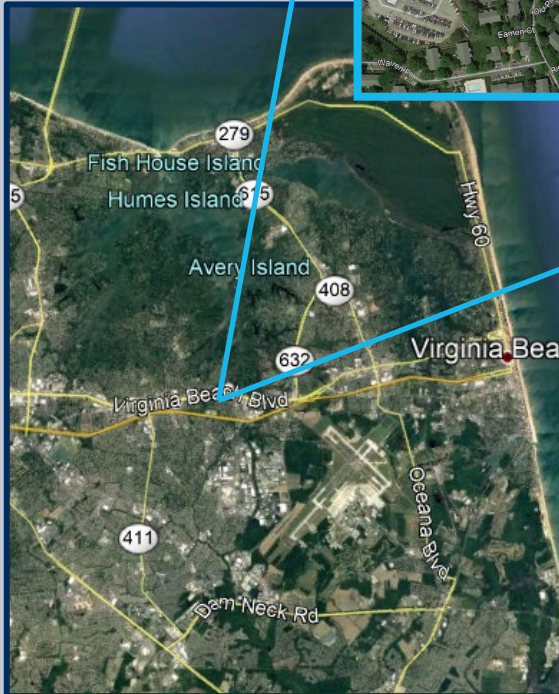
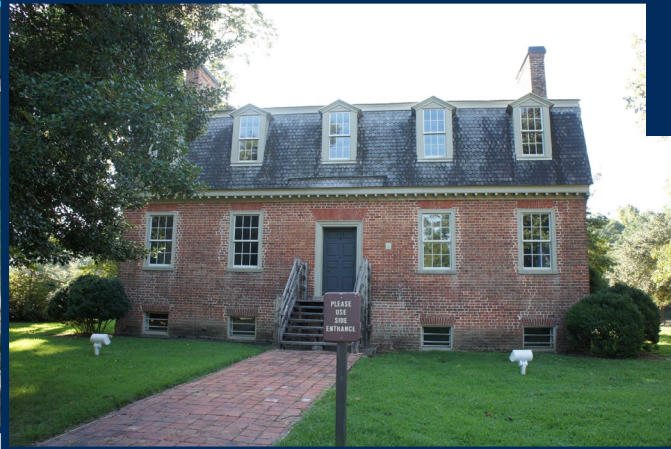
CASE STUDY 4: MUNICIPAL HOUSE MUSEUM

- Landlocked in north central Virginia Beach
- House Built: c1805
- Historic District Designation(s):
 - Local Historic District
 - Individual Virginia Landmarks Register
 - Individual National Register of Historic Places
 - Potentially eligible for exemption
- Reason for initial contact between client and CPG/MR/BRS:
 - Serving as a historic preservation consultant on major renovation

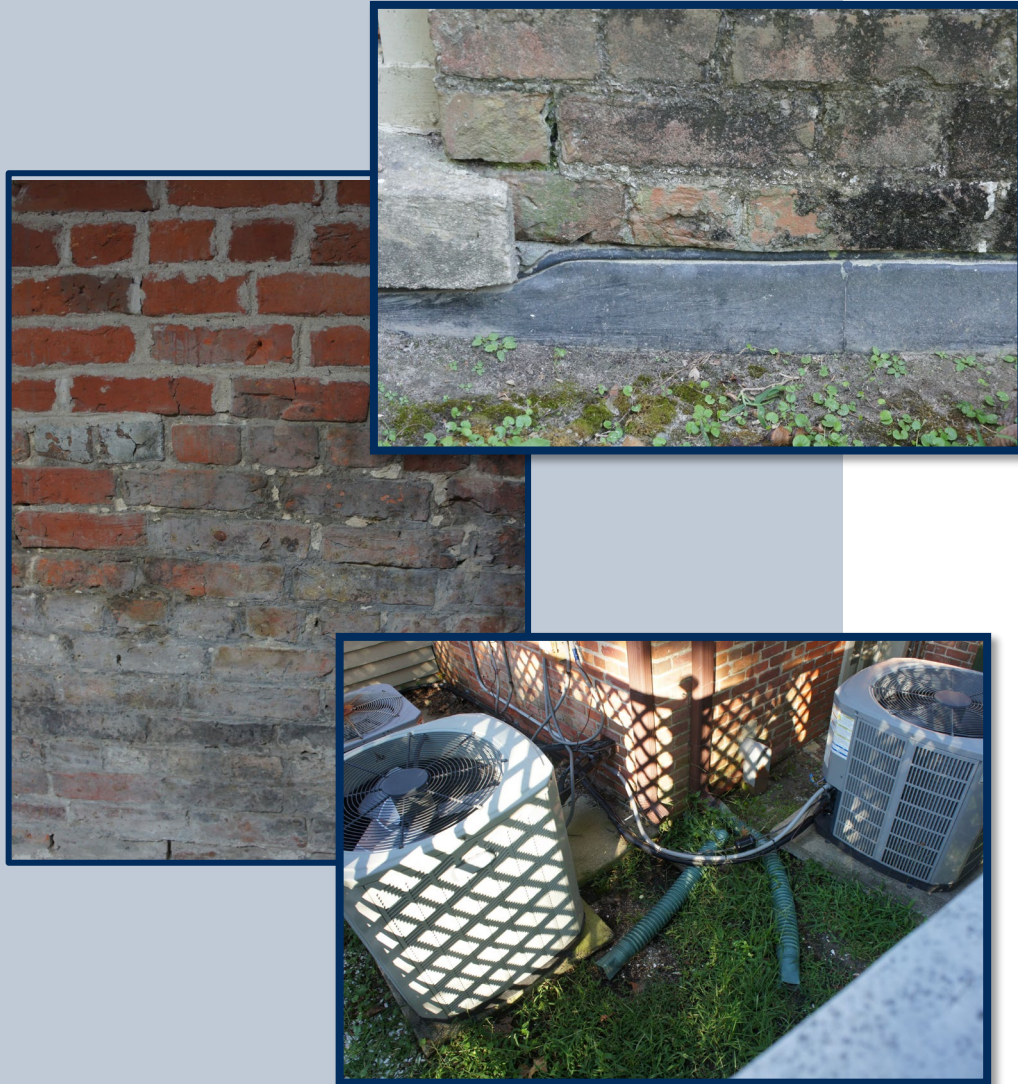
CASE STUDY 4: MUNICIPAL HOUSE MUSEUM

- 1950s:
 - Basement renovation – concrete floor then tiled
- Late 1970s and Early 2010s:
 - Installation of moisture barriers during rehabilitation projects
- 2020 Renovation
 - proposed materials replacement similar to above work
- Initial Assessment:
 - Previous renovations and maintenance issues contributed to historic material degradation
 - No initial testing performed before renovation plans
 - Proposed work does not address cause of moisture issues, rather applied contemporary solution to a historic building that would likely cause same damage

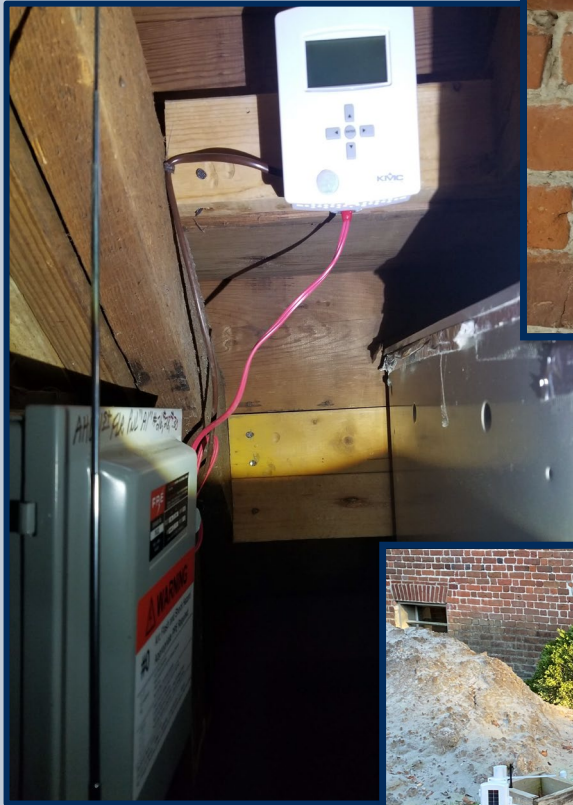
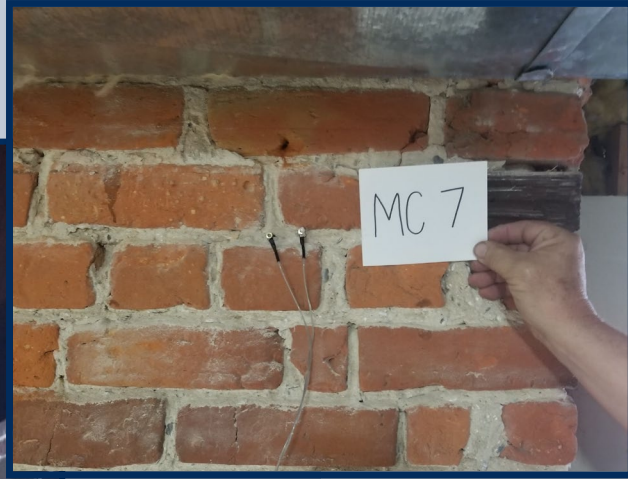
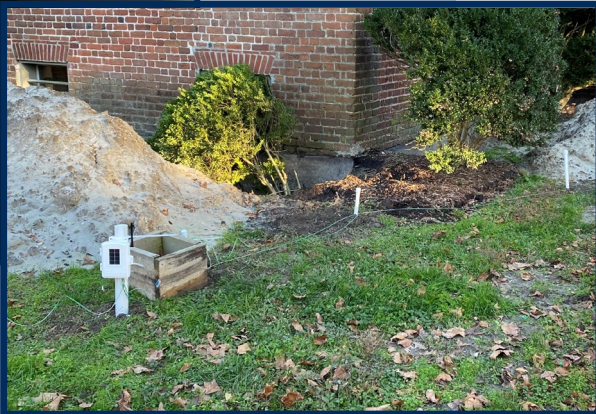
CASE STUDY 4: MUNICIPAL HOUSE MUSEUM

- Monitoring the site:
 - Equipment installed for 36-40 days
 - Soil moisture monitors measured for 26 days
 - Continuous measurements
 - Probes distributed throughout basement
 - Tidal position measurements
 - Temperature
 - Relative humidity
