Testing the Flood Resiliency of Historic Exterior Wall Systems, Plaster Using Test Protocol BRS 2-22

Protocol 2 Report

December 2022

BUILDING RESILIENT SOLUTIONS

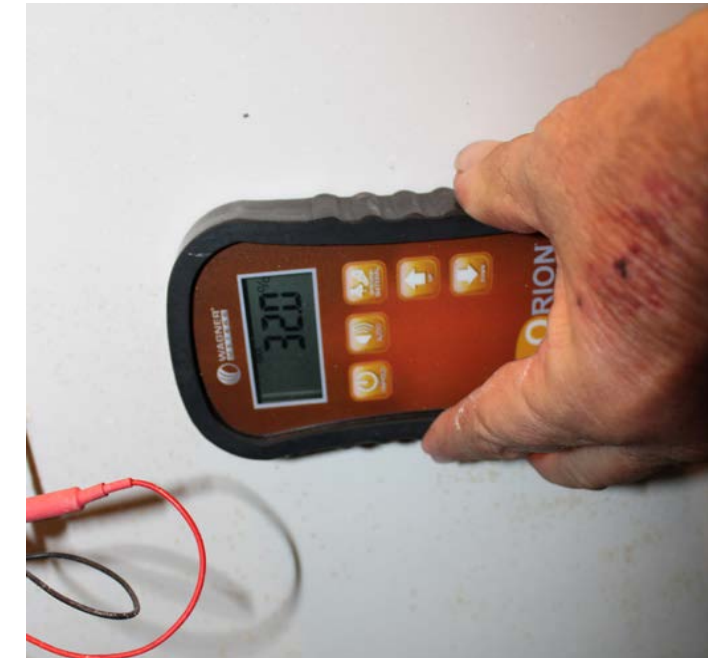
Figure 11 - Measuring moisture content after draining.

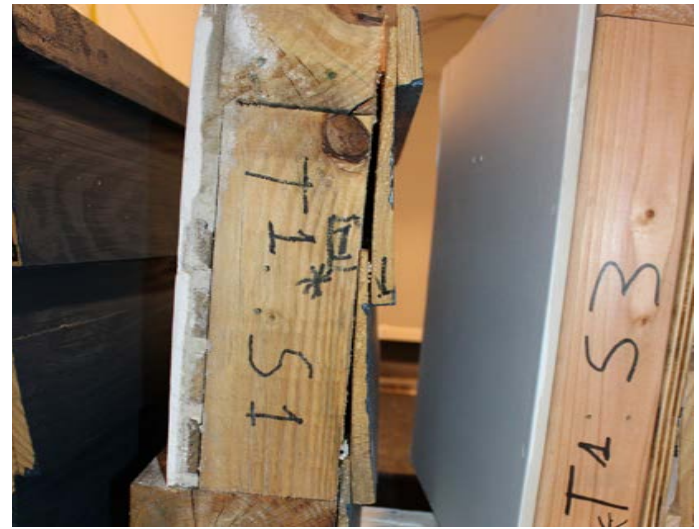
change in cross sectional dimensions. The siding remained cupped. The split that had previously developed in one piece of siding separated to a dimension of 0.25" at the leading edge; this split was located in the center of the broad face and appeared to be a result of cupping and swelling that placed stress on the board since it was nailed in place and unable to move or grow across the grain. The sample was photographed to record its appearance (See Figure 14).

Figures 15 - Sample 1 after final drying.

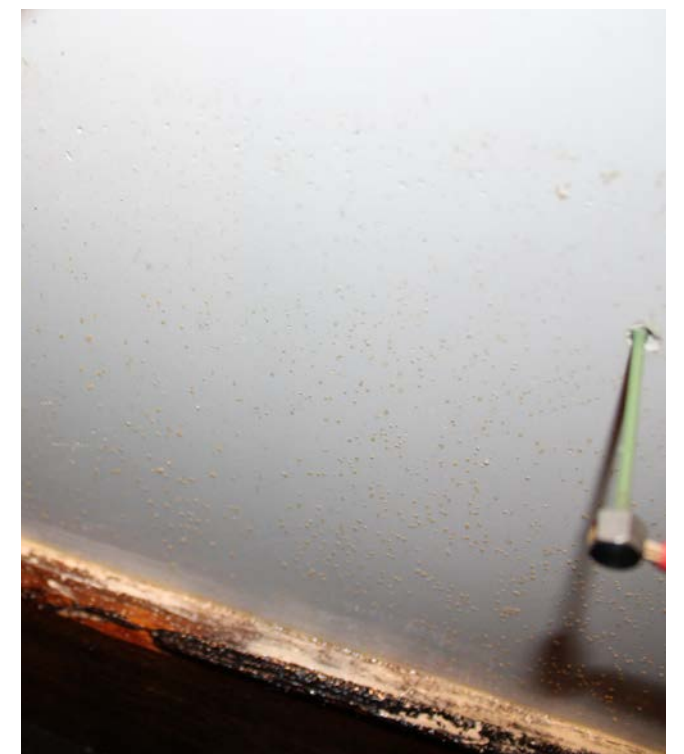
Appendix A3 Figure 16 - Sample 1 crystallized granules on plaster post-draining.

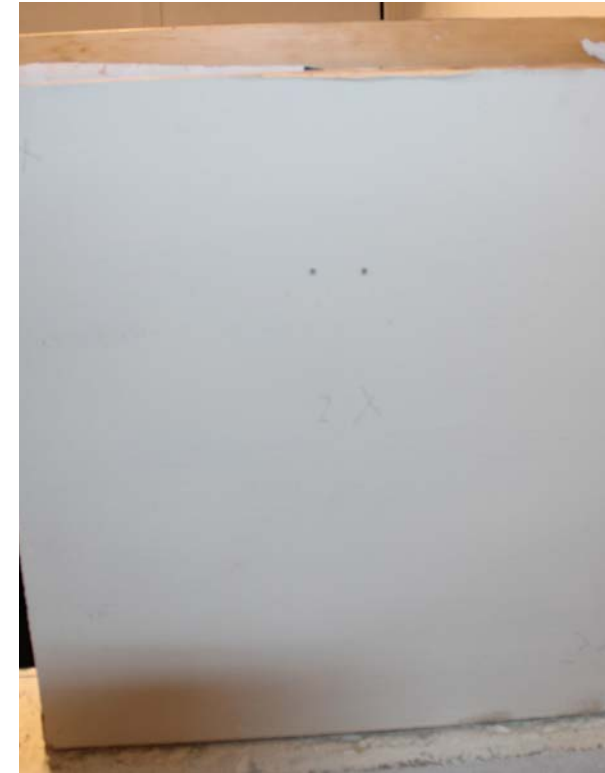
Appendix C3 Figure 13 - Sample 3 post-drying.

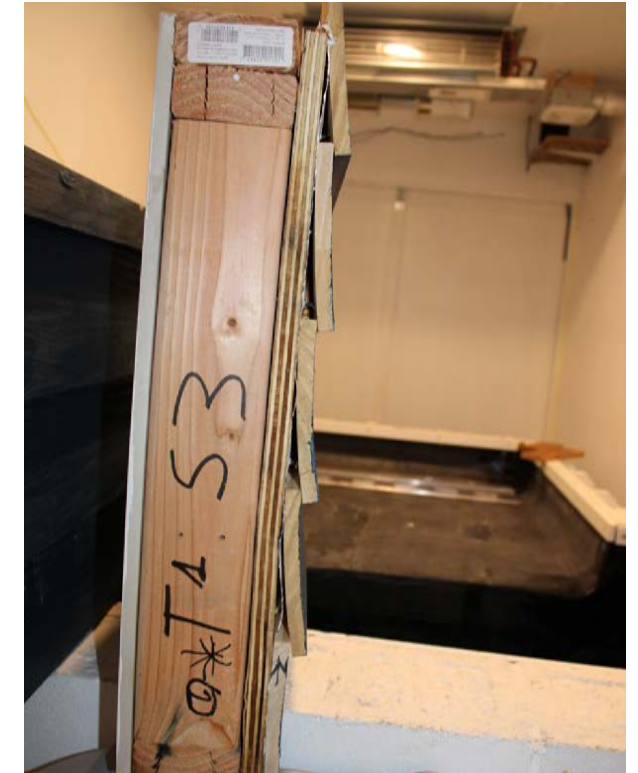
Appendix C3 Figure 14 - Sample 3 post-drying.
